Moisture & Liquid Indicator

Installation Instructions

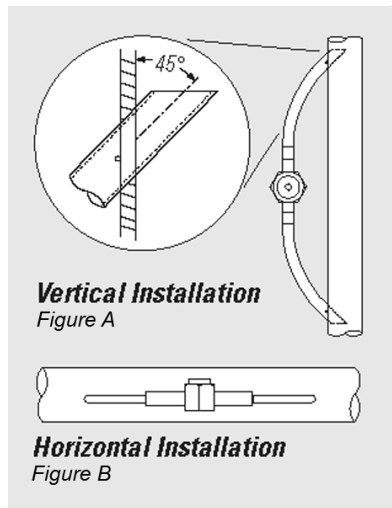
The YELLOW JACKET Moisture and Liquid Indicator may be installed in a bypass to the main liquid line when desired - and must be installed in this manner on lines larger than 2-1/8" O.D.

While satisfactory liquid and moisture indication will generally be obtained in any position, preferred methods of installation are shown in Figures A and B.
